REPORT NUMBER: MGA-C13L4-014M2.1

**HEAT STROKE EVALUATION
THE FIRST YEARS TRUE FIT iALERT C685**

**PREPARED BY:
MGA RESEARCH CORPORATION
11480 ROBERTSON DR.
MANASSAS, VA 20109**

FINAL REPORT

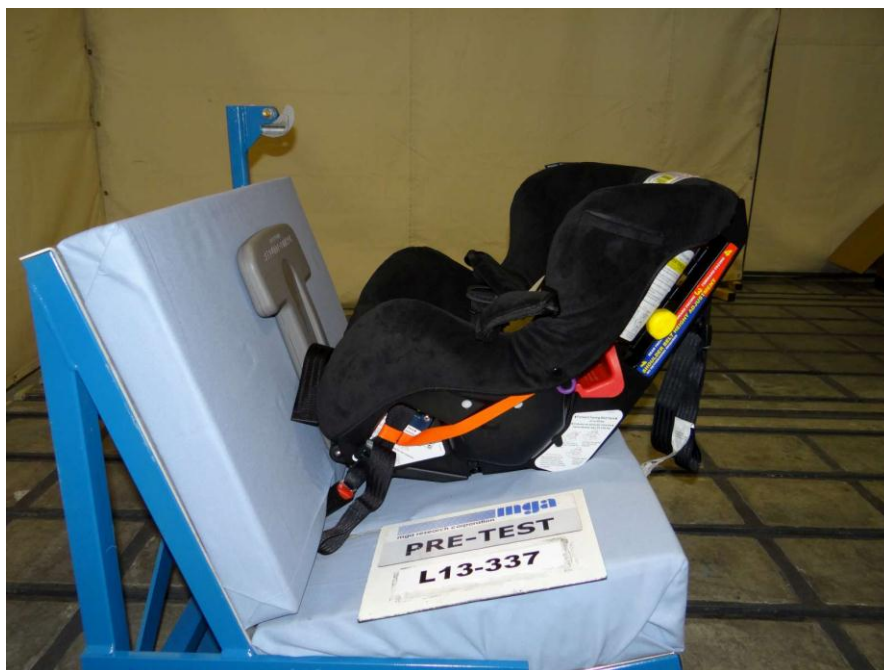
Figure 1: iAlert C685 installed on simulated seat used for a portion of the assessments

MGA Research Corporation was contracted by Alpha Technology Associates, Inc. under contract #DTNH22-080-D-00088 to conduct a series of evaluations on the First Years True Fit iAlert C685 child restraint system (CRS) (Figure 1). The iAlert C685 is sold as a complete child seat and not just an insert that can be added to an existing child seat. The procedure for evaluation of this product was written by MGA Research. The procedure was based upon a previous project conducted by the Children's Hospital of Philadelphia (CHOP), report number DOT HS 811 632, as well as input from NHTSA.

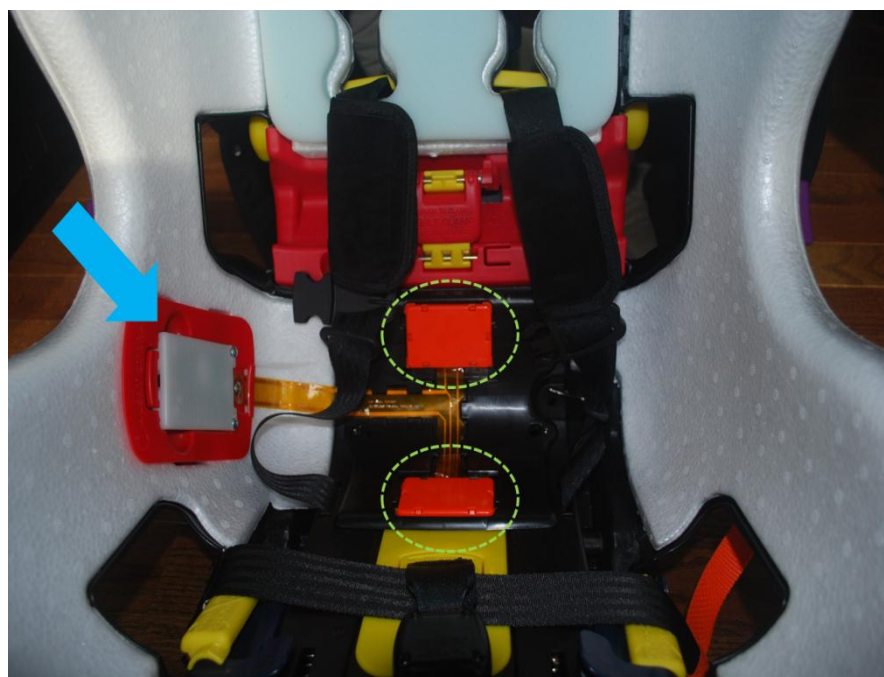
Figure 2: View of True Fit iAlert C685 with cover removed showing control module (indicated by blue arrow) and weight-detection switches (indicated with dashed green ellipses)

The iAlert system consists of a control module and pair of weight-detection switches (Figure 2) which monitor the CRS and communicate status to a smartphone. The control module monitors motion, temperature, seat position, and whether a child is seated in the CRS. After initial setup, the system activates upon sensing a child has been placed in the CRS. The control module establishes a communication link with the parent's or caregiver's smartphone and provides notifications in certain circumstances such as if the vehicle has been stopped for a predetermined length of time without the child leaving the CRS.

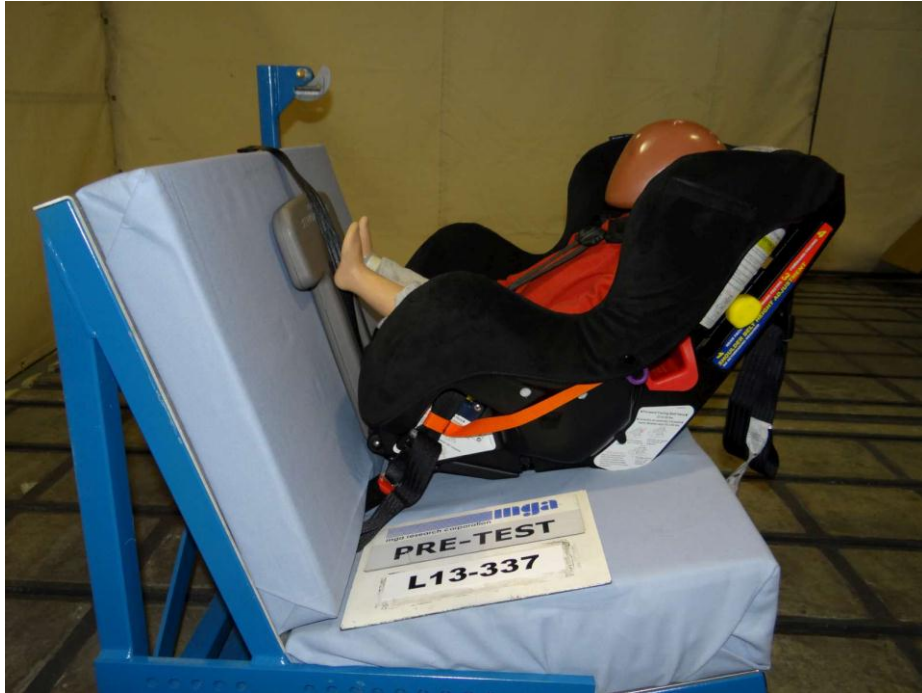
Figure 3: iAlert C685 installed rear facing with 12mo ATD

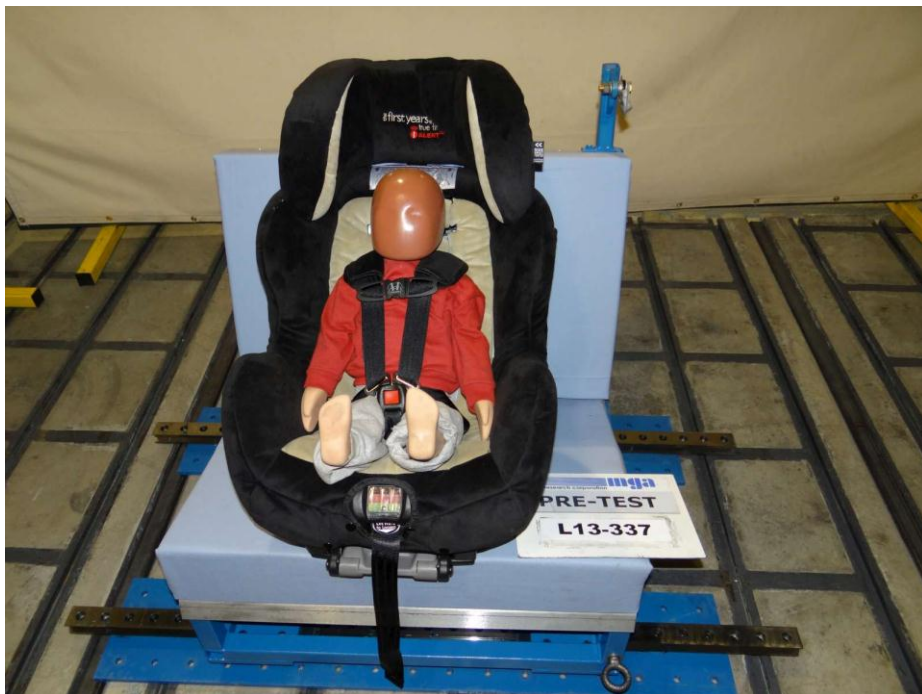
Figure 4: iAlert C685 installed forward facing with 12mo ATD

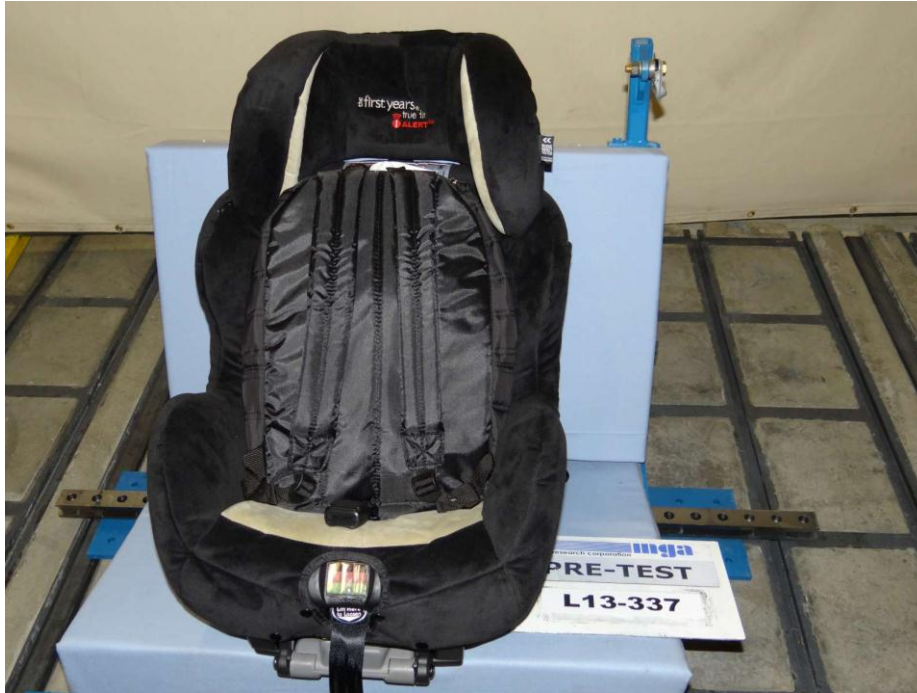
Figure 5: iAlert C685 with a 5.5lb backpack used for misuse activation assessment

Trial 1	Trial 2	Trial 3	Trial 4	Trial 5	Overall
Forward Facing	22lb 12mo ATD	OK	OK	OK	OK	OK	OK
	35lb 3yo ATD	OK	OK	OK	OK	OK	OK
	62lb 6yo ATD	OK	OK	OK	OK	OK	OK
	5.5lb backpack	NO	NO	NO	NO	NO	NO
Rear Facing	7lb newborn ATD	OK (1)	OK	OK	OK	OK	OK
	22lb 12mo ATD	OK	OK	OK	OK	OK	OK
	5.5lb backpack	NO	NO	NO	NO	NO	NO

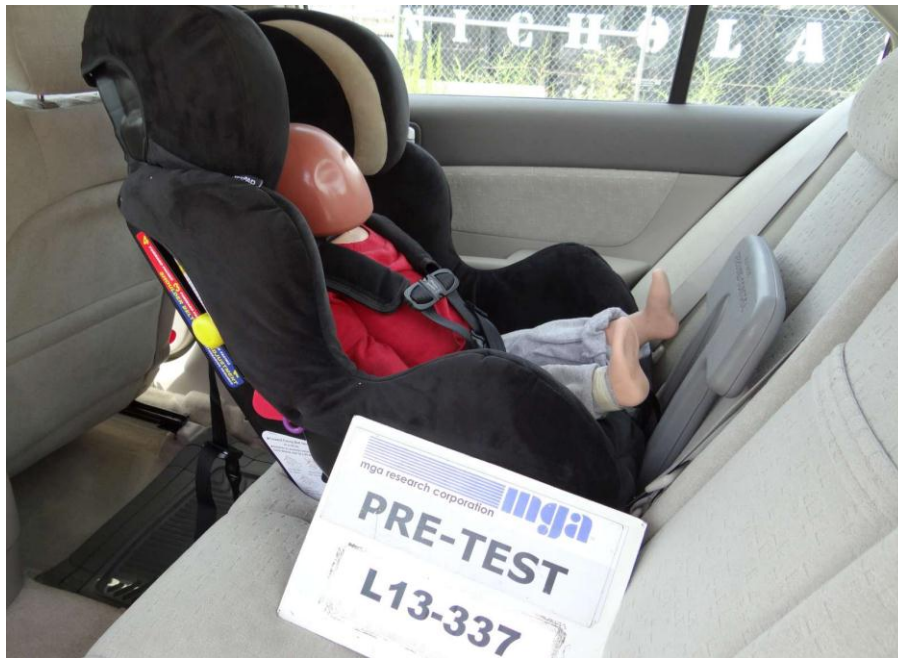
Figure 8: iAlert C685 installed in a 2007 Hyundai Sonata for the unobstructed notification assessment

- 1) Scenario One involved no obstructions between the CRS and the smartphone. The CRS was installed rear facing with a 12 month old ATD using the lower anchor connectors in the rear seat of a 2007 Hyundai Sonata (Figure 8). The car was not running during the tests, all doors were closed and windows were rolled up. The engineer confirmed communication between the smartphone and CRS and proceeded to walk away in a straight line, at a constant rate, until a notification appeared on the phone. The distance from the CRS to the location where the application notified the engineer was recorded (Figure 9).

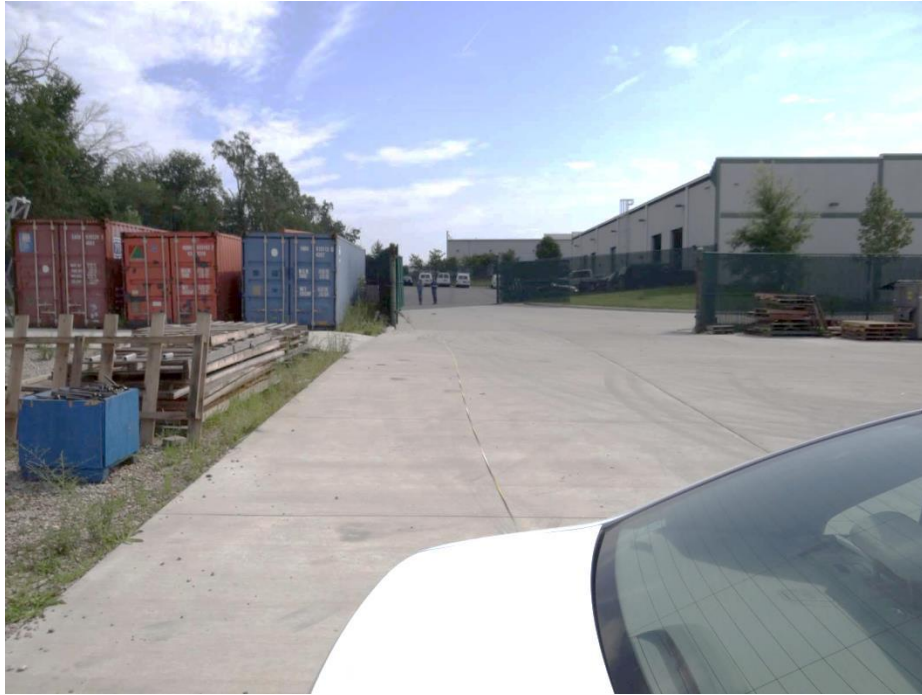
Figure 9: Outdoor unobstructed area used for notification assessment

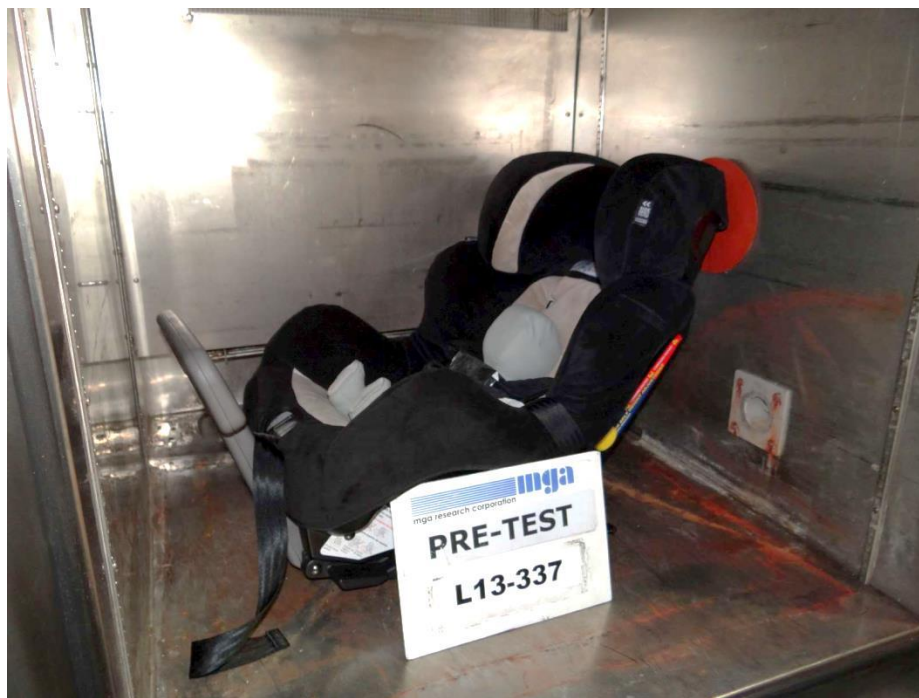
Figure 10: Installation of iAlert C685 in temperature chamber for temperature notification assessment

In order to assess the temperature warning capabilities of the system the CRS was placed inside of a temperature controllable chamber (Figure 10). A newborn ATD was secured in the seat with additional weight of 9lb to ensure a reliable activation was made with the seat. The temperature chamber's thermocouple was located along an upper edge of the chamber, away from the seat. A temperature sensor was placed on the seat next to the internal iAlert temperature sensor to record the local temperature (Figure 11). The starting temperature of the iAlert C685 was 90°F. The temperature chamber was set to maintain ambient temperature for several minutes before beginning a profile to heat from ambient to 120°F at a rate of 6°F per 5 minute interval. The temperature profile was chosen by NHTSA based on findings from a study published in Pediatrics Vol. 116 No. 1 July 2005. After 40 minutes of incremental heating the chamber was set to maintain 120°F. After an additional 25 minutes the iAlert temperature sensor conveyed no warning to the smartphone. The chamber temperature was then increased to 160°F. The ATD was removed at that time to prevent any damage from occurring. Temperature readings are shown in Figure 12.

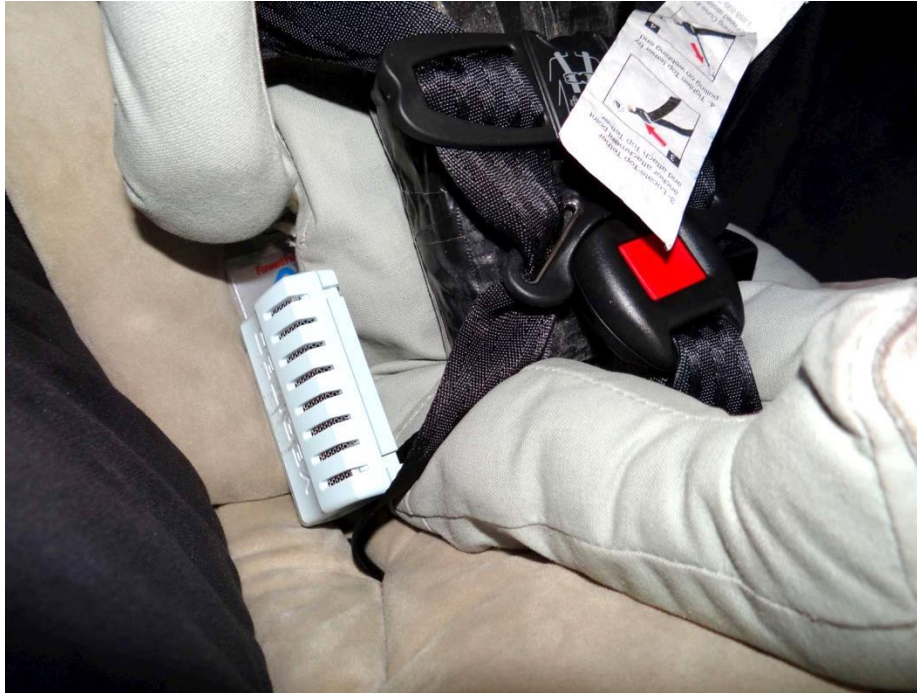
Figure 11: Temperature recorder installed on seat near iAlert module

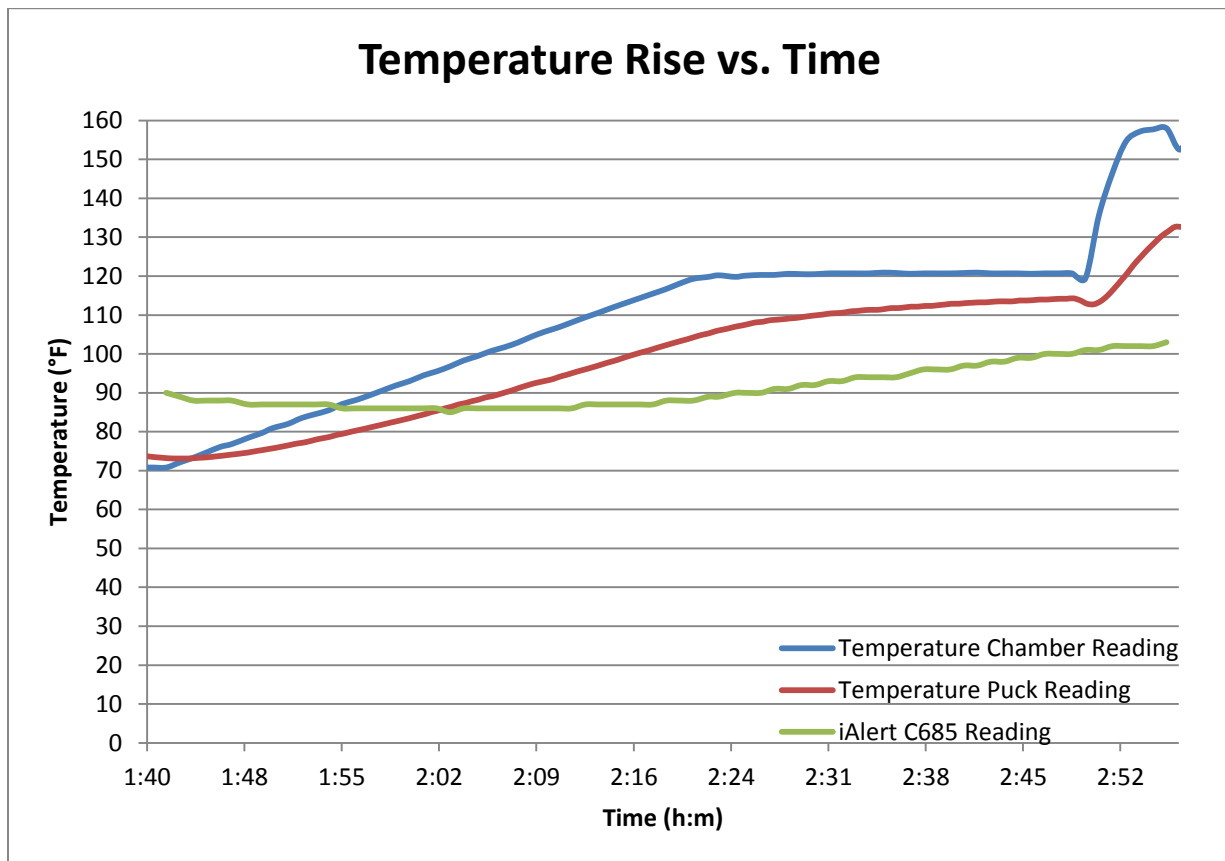
Figure 12: Combined temperature readings from the temperature notification assessment

When the iAlert reached 101°F the temperature icon on the status screen of the phone application turned red. There was no audible alarm, vibration, or popup alert that notified the user of the temperature increase.

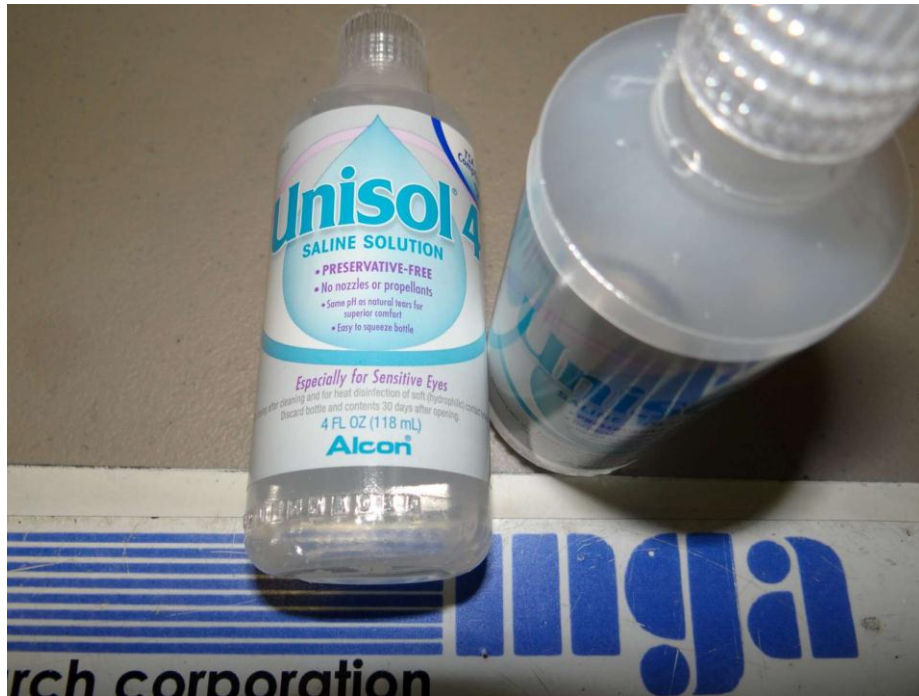
Figure 13: Saline used for misuse assessment

The final assessment conducted by MGA was a misuse scenario involving liquid contacting the activation switches on the CRS. The CRS was installed rear-facing using the lower anchors to the simulated seat inside of the lab. Four (4) liquid ounces of saline solution (Figure 13) was poured directly on the lower contact switch in the CRS (See Figure 14). A 12mo ATD was briefly installed and removed to evaluate functionality of the system immediately after the saline was poured and every 5 minutes thereafter. If a child is seated in the CRS, the smartphone application will display 'connected' as the status. If the child is found to no longer be seated in the CRS, the smartphone application will display 'disconnected.'

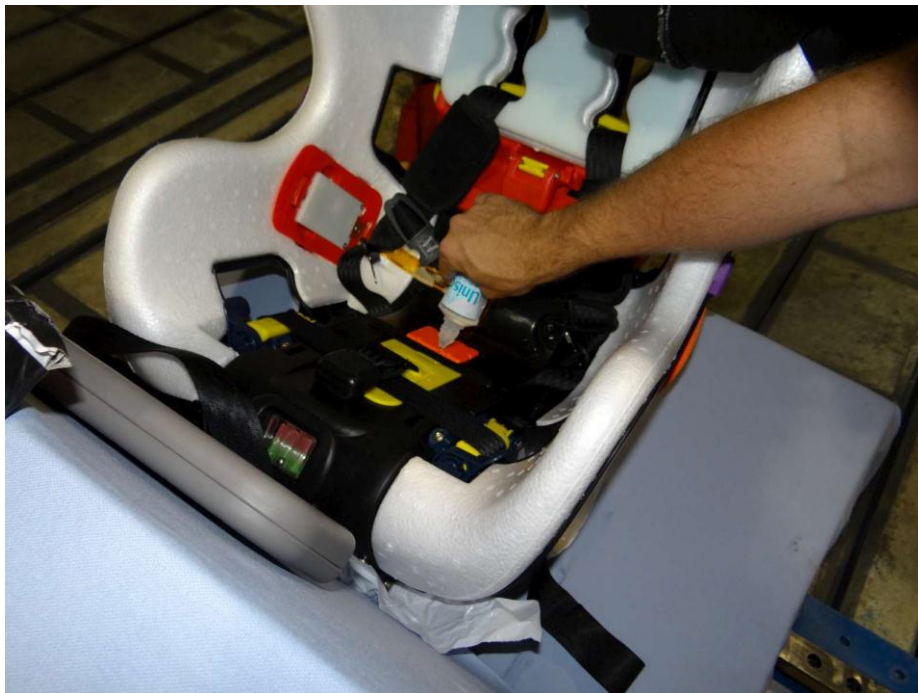
Figure 14: Saline application to lower switch housing on CRS

After examining the electrical connections on the system, the engineer noted saline in contact with the exposed electrical traces. Continuity was checked at the battery/Bluetooth connection using a digital multimeter. There was resistance across the normally isolated connection, indicative of a shorted circuit. The electrical system was gently removed from the seat and dried off with a towel in an attempt to clean the system. After cleaning, the system continued to falsely report a child in seat.
